MONITORING ANIMAL USE OF
MODIFIED DRAINAGE CULVERTS ON
THE LOLO SOUTH PROJECT

FHWA/MT-01-004/8117-15

Final Report

Final Report For:
Monitoring Animal Use of Modified Drainage Culverts on the Lolo South Project

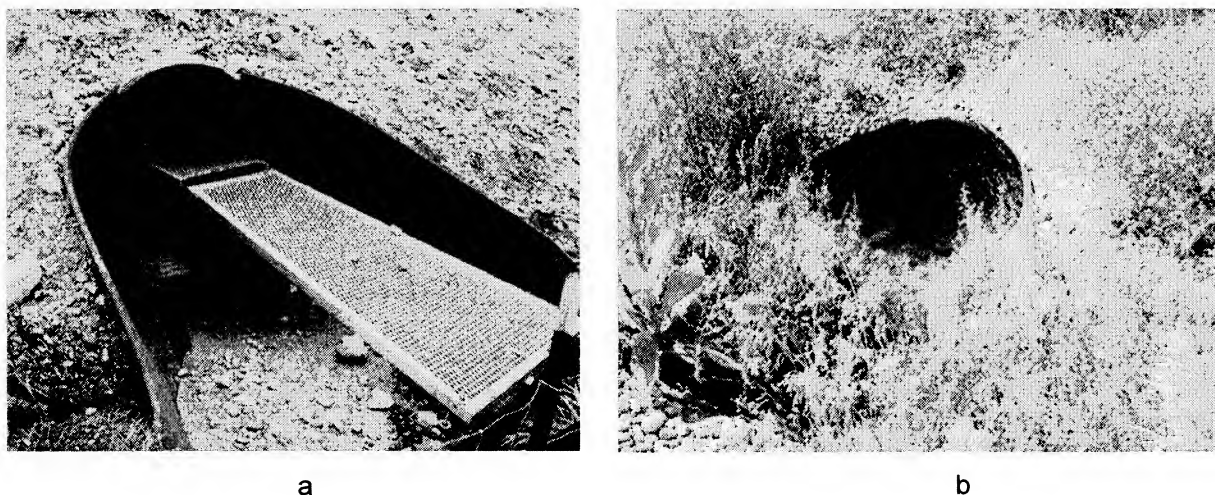
Figure 1. (a) Example of a culvert containing a ramp/shelf animal walkway (Carleton Creek experimental), and (b) one not containing a walkway (Carleton Creek control).

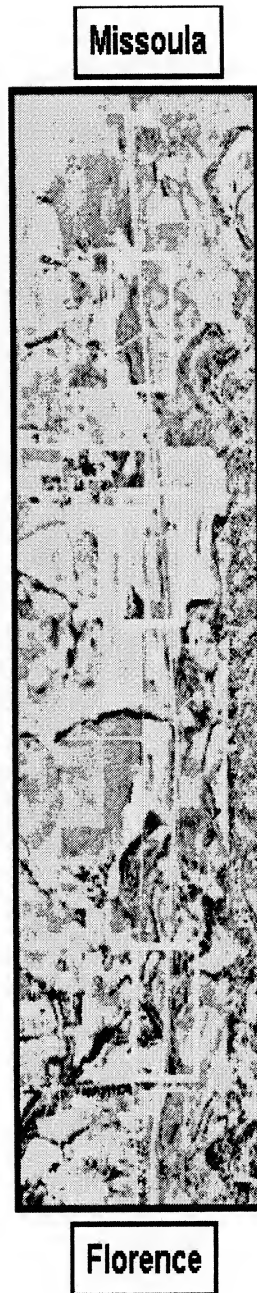
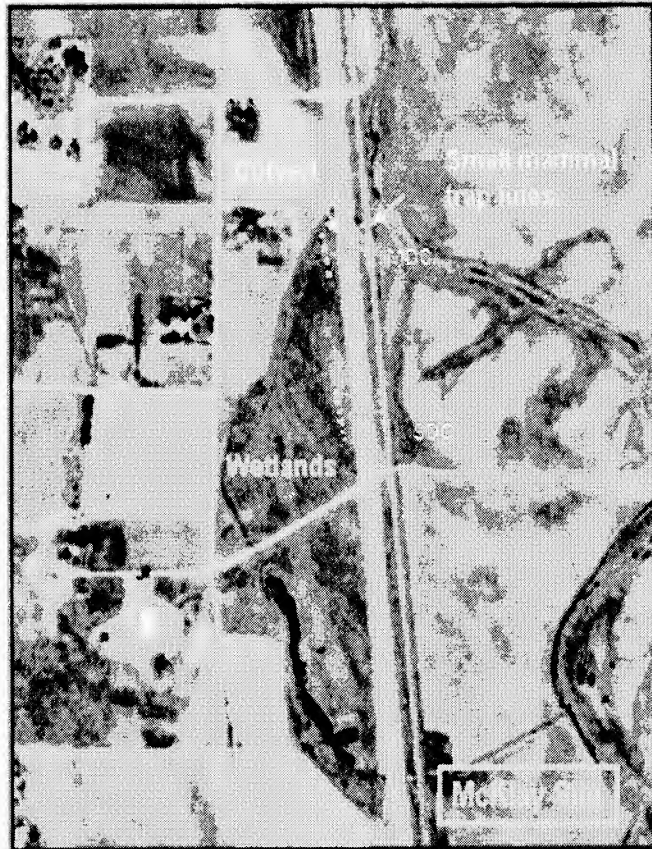
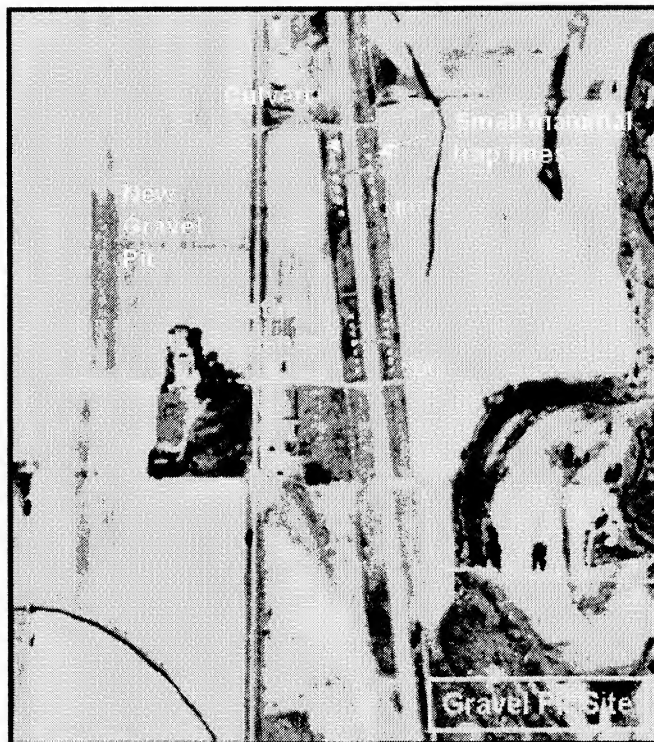
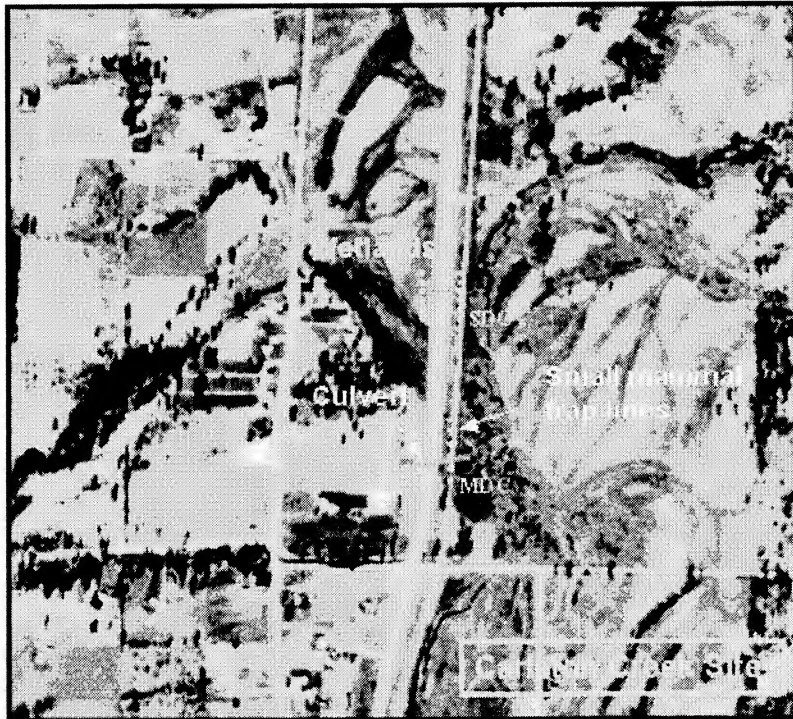
Figure 2. Paired culverts spaced along U.S. Highway 93 between Lolo and Florence, Montana (this page and following two pages) (a) Overview of study sites, and closeup (b,c, & d) images of individual pairs illustrating placement of trap transects.

During January, February, and March, the snow levels were too deep to permit small mammal sampling with the transect lines. On March 31st, live-trap transects were placed at a 90° angle along both entrances of 4 culverts (2 control and 2 experimental; Carleton Creek and Gravel Pit sites) as well as at the west entrance of a 3rd experimental culvert (McKlay Creek). The east entrance to this last culvert was adjacent to a residence and was not sampled. The remaining control culvert was completely filled with ice when the study was initiated and it was thought that the water levels would drop during the summer months making this culvert accessible. However, the water levels remained high during the entire study rendering this culvert inaccessible so these entrances were also not sampled. Traps transects were run for a 3-day period from late March through August. Animals captured were identified to species, sexed, weighed, and their reproductive condition noted. All animals were temporally marked for population assessment. Deer mice were marked with colored ear tags beginning in June, in conjunction with one undergraduate study, so that it could be determined from which population (east or west of the highway) individuals originated. A total of 7,650 trapping opportunities were recorded during the study [1 trapping opportunity = 1 trap accessible over a 12 h period. Traps were checked each morning and evening (March - June sampling) to minimize mortality thus during this period each trap recorded 2 trapping opportunities per day. During July and August traps were only opened in the evening and closed during the day due to extreme heat; thus only one 12 h period was sampled each day. This was not thought to alter trapping information since the species being captured were essentially nocturnal]. A total of 1,017 captures were recorded representing 7 species (Table 2). Four of 7 species (deer mice, meadow voles, vagrant shrews, and short-tailed weasels) were captured on both sides of the highway; the house mouse and Columbian ground squirrels were captured only on the west side, while the single capture of the western jumping mouse occurred on the east side. Some variation in total number of captures occurred between sites most likely as a result of vegetative differences, but, in general, eastern sides were similar to one another and western sides were similar to one another. Sixty-two percent of the total captures were on the east side, while 38% were on the west.

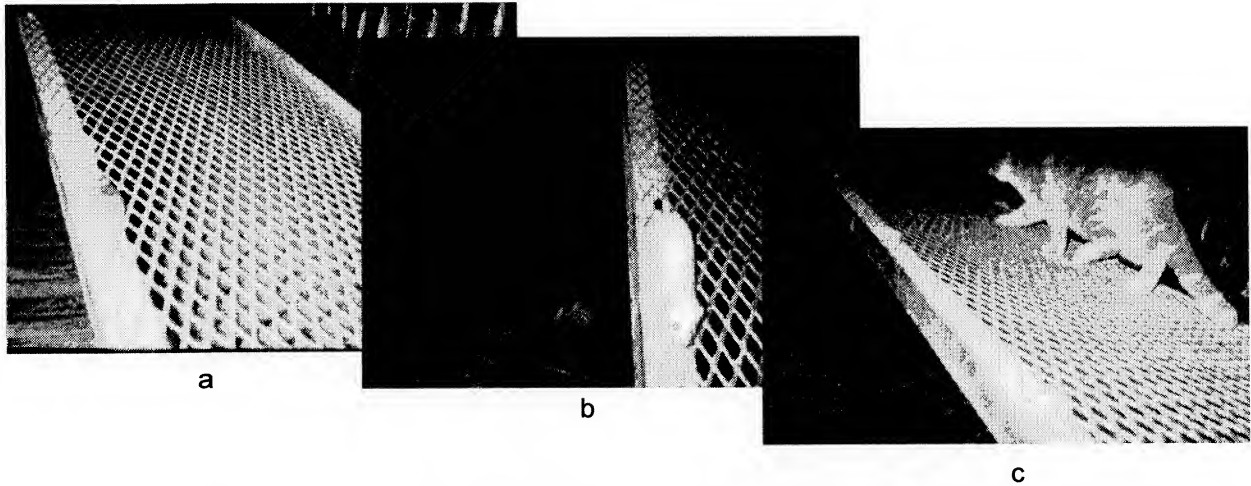
Figure 3. Deer mouse (a), short-tailed weasel (b), and domestic cat (c) use of shelves when culverts were carrying water. (Note use of frame by deer mouse and weasel)

The purpose of the animal walkways is to provide use of the culverts even when they are carrying water. Three species [deer mouse (*Peromyscus maniculatus*), short-tailed weasel (*Mustela erminea*), and domestic cat (*Felis catus*)] were documented using these shelves when water was present; when these same culverts were dry, these species as well as 2 others [raccoon (*Procyon lotor*) and striped skunk (*Mephitis mephitis*)] moved along the floor (Figs. 3 & 4). The smaller species to use the shelves, deer mice and short-tailed weasels, did so by carefully walking along the outside frame rather than over the shelf mesh surface (Fig. 3 a,b). This is an important observation as it suggests that a more solid floor surface may be preferred by these smaller animals. Muskrat (*Ondatra zibethicus*) were observed not only walking through a dry culvert but also swimming through culverts when water was present (Fig. 5).

- 2) The most important question being addressed by this research has been answered: small mammals do use the ramp/shelf when the culvert floor is covered with water. Deer mice and short-tailed weasels, which would otherwise be too small to use these culverts when any water was present, freely used the shelves under these conditions. Raccoons, an obviously larger species and one adapted to forage in water, freely walked through culverts even when 6-8 inches of water was flowing. Striped skunks were not observed using the shelf during water flow. This may have been due to the fact that during much of this time, the ramps accessing the shelves were mounted over two feet above the ground. Deer mice and weasels are excellent jumpers, while skunks are not.

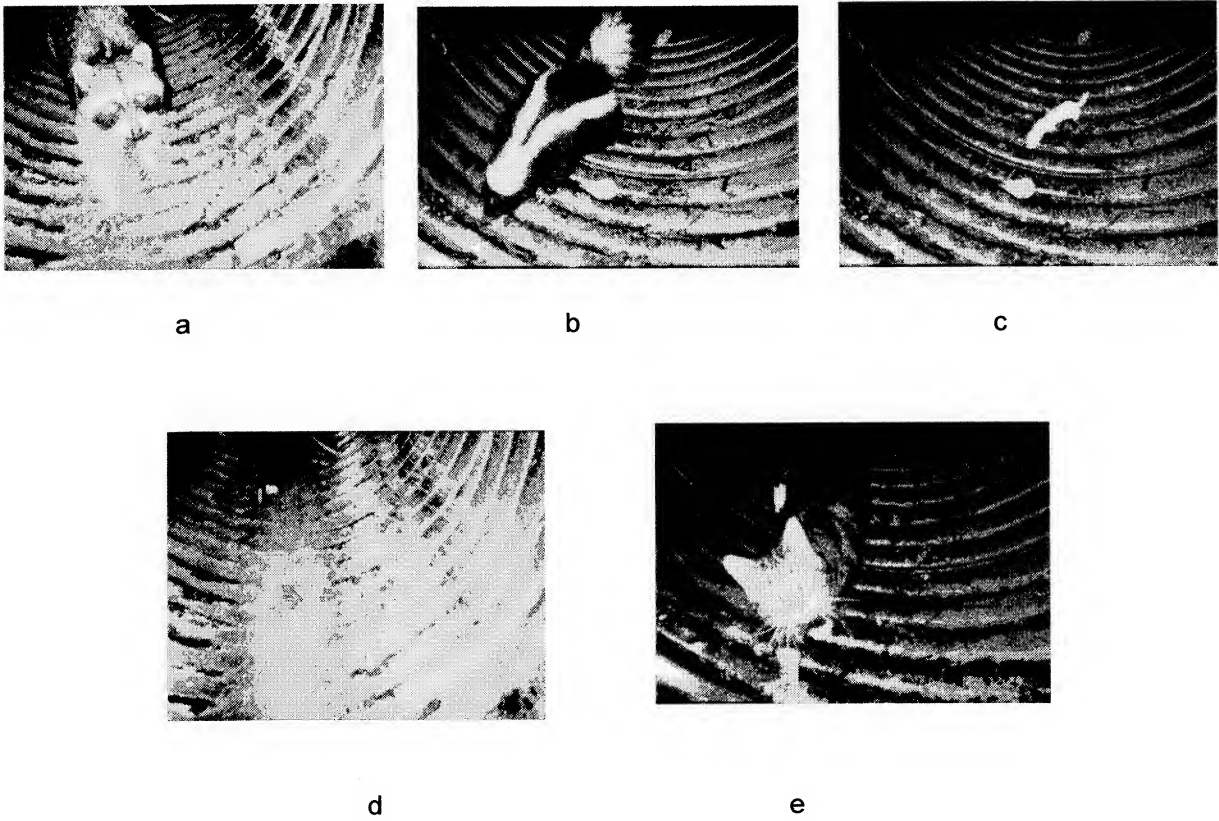
Figure 4. Raccoon (a), striped skunk (b), short-tailed weasel (c), deer mouse (d), and domestic cat (e) using culverts when dry.

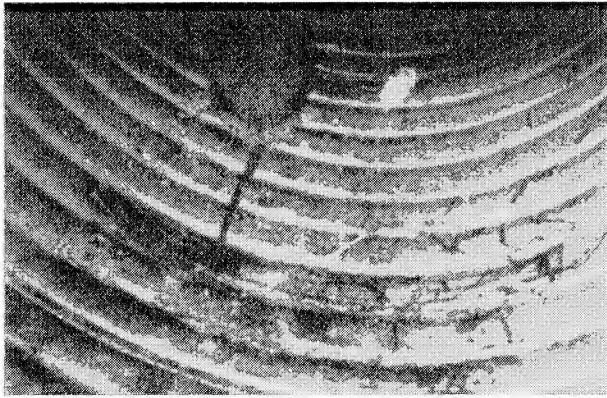
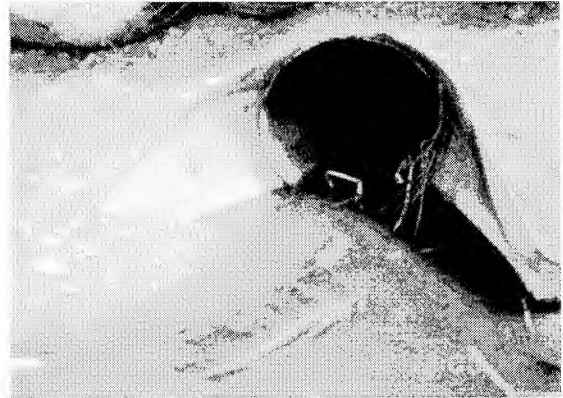
Figure 5. Use of culverts by muskrat during dry (a) and wet (b) periods.

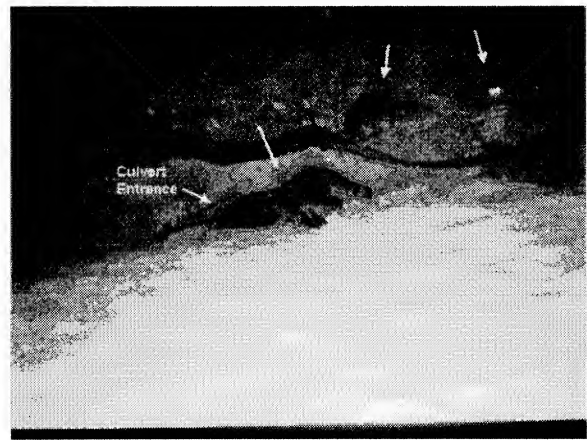
Figure 6. Raccoons photographed at the entrance to an experimental (a) and control (b) culvert. The experimental culvert contained ice up-to-and-covering the shelf though adequate space was available for movement through. The control culvert angled downward to such a degree that its entrance on the east side was completely underwater throughout the 3-month period from January to March. Raccoons, however, still visited it on nearly a nightly basis.

Species such as the raccoon seem to pay particular interest in the culverts and use them even when nearly full (Fig. 6). Ninety-eight percent of all animal use of the culverts during this study occurred during darkness. No correlation was observed between activity patterns and

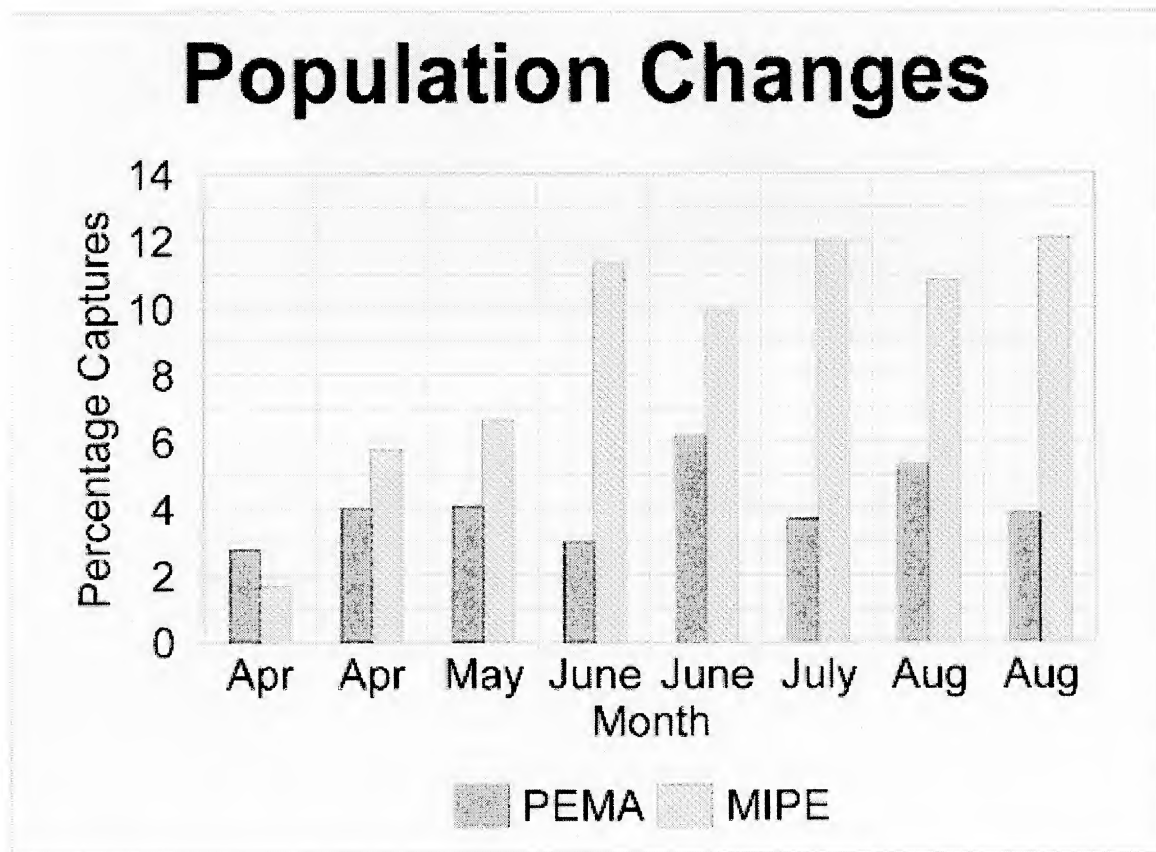
Figure 7. Population changes observed in deer mice (PEMA) and meadow voles (MIPE) during the spring and summer expressed as percentage of captures.

Though population estimates for deer mice and meadow voles (the only two species with enough captures for analysis) were not calculated due to incomplete recapture records, general trends in population size can be interpreted from overall trapping numbers. Population numbers for both species increased from spring to summer, though a much more significant increase was observed in meadow voles (Fig. 7).

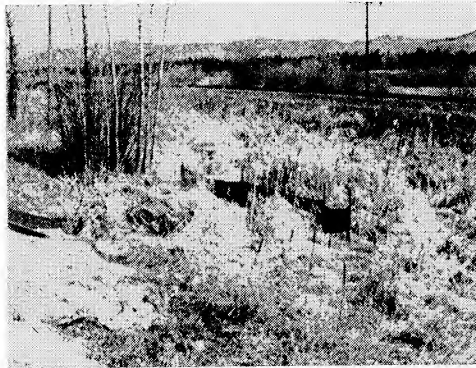
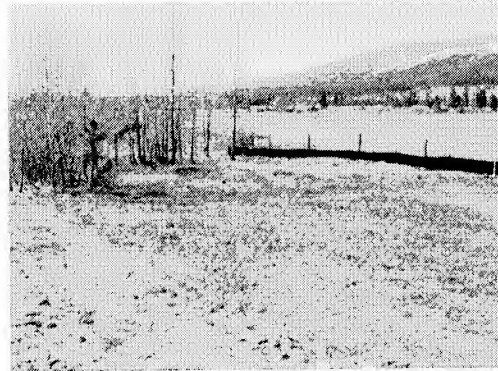
Figure 8. Example of the vegetative cover at the east (a) and west (b) entrances to one culvert in April (Gravel Pit experimental).

Vegetation analyses indicated that in most respects ground cover at the east entrance to the culverts was greater and more consistently established than that at the west entrances (Fig. 8). During a majority of the initial 3-month period, these areas were covered by snow (Fig. 9).

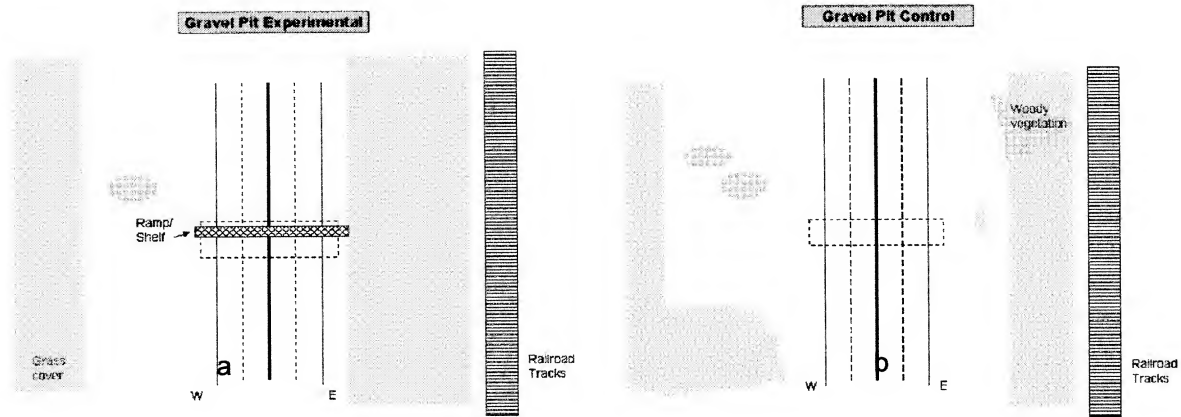
Figure 10. Example of vegetative maps developed for experimental (a) and control (b) culverts.

Initial vegetative maps were constructed for each site so that the relationship between vegetative cover and animal populations could be assessed (Fig. 10). It became apparent that only a general overview of vegetative cover could be developed since sites particularly along the western side of the highway were greatly disturbed and were being modified throughout the study (grading and reseeding during the spring and early summer; mowing during mid-to-late summer). Considerable vegetative growth occurred, however, at the entrances to the culverts on the western side as well as all along the eastern side during the summer (Fig. 11).

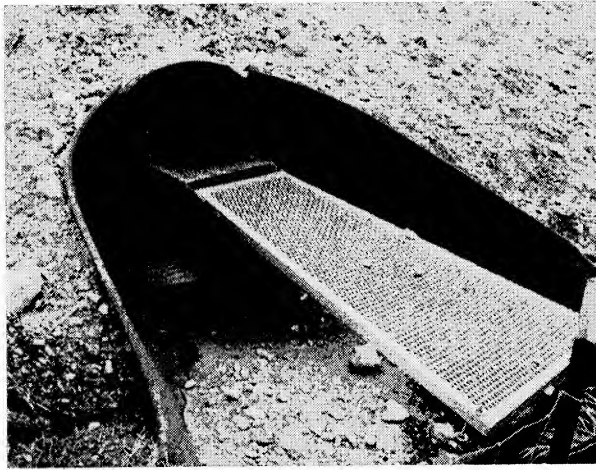
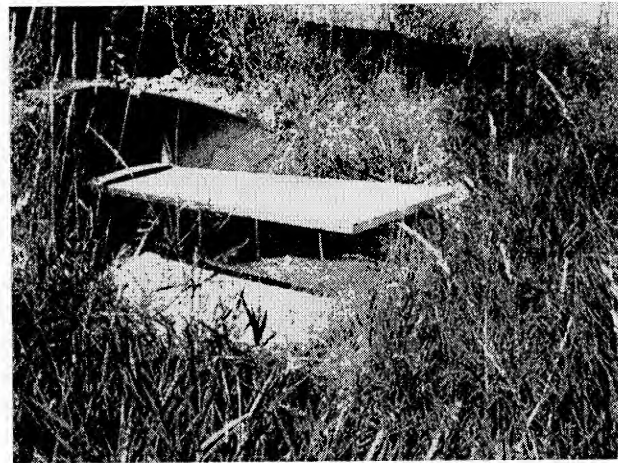
Figure 12. Ramp adjustments made during the study by MDT. (a) Initial ramp placement so that it contacts the ground and (b) final placement so that it sits above the ground surface.

When the ramps accessing the culverts were first put in place, they angled down from the shelves to the ground surface (Fig. 12a). During the summer the ramps were adjusted by MDT and welded in place so that they projected directly outward from the shelves causing them to open approximately 2.5 feet above the ground surface (Fig. 12b). It is unclear why this modification was made, but presumably this was to prevent any debris from being trapped under the ramp during periods of water flow. No indication was given prior to this change that this was to occur. Obviously when water is moving through the culvert, the ramps, as initially placed, would be covered and thus inaccessible to animals. However, when no water is present the elevated ramps would also prevent most animal use since the ramps are suspended too high above the ground for access. In order to address water flow and debris concerns while at the same time keeping the ramps accessible to smaller animals a modification of the entrance ramps is proposed. The modification would entail expansion of the elevated ramp to the side of the culvert so that it contacts the sloping hillside, while remaining above water level. This modification will be tested in the continuing study.

Thirdly, the final position at which the ramps accessing the shelves were set seems problematic. The assumption is that the ramps were welded in to this position to facilitate movement of debris through the culverts; however, this defeats their purpose to serve as a ramp to the shelf. Species such as the striped skunk, which routinely used the culverts during dry conditions, were never observed using a ramp. It is very possible that they could not jump the required 2.5 feet to the ramp surface. The shelf texture, as described above, may also have contributed to their lack of use. One possible way to modify the ramp so that debris could still freely move beneath while allowing access to small animals would be to extend the ramp surface sideways so that it came in contact with the adjacent hillside.

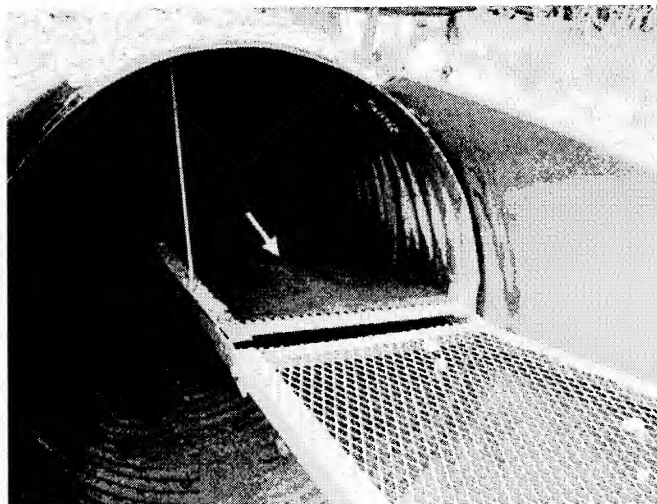
Figure 13. The shelf surface has been covered with heavy gauge plastic (truck bed liner material; yellow arrow) to provide a solid surface for smaller species.

The observations made have raised several issues which need to be addressed in future studies. First is the fact that the shelf surface is probably not appropriate for most of the smaller species. The 1+ inch openings in the shelf grate appear to discourage small mammal movement. Most observations of deer mice and short-tailed weasels illustrated that they preferred to travel along the solid metal frame which supports the shelf. This is not surprising. The grate surface obviously needs to be porous to allow water to flow through during periods of water flux; however, the size of the openings may discourage use by such small species. Even larger species (e.g., dogs) are known to avoid such grate surfaces (personal observation). A solid surface is currently being tested; results will be provided when they are completed (Fig. 13; refer also to

In order to further test the observation that small species seem to prefer a more solid surface, one shelf was covered with a solid, heavy gauge plastic (a polypropylene material used for truck bed liners; refer to Fig. 13 above; Fig. 15 below) on July 15th. A comparison is thus being made between animal use prior to and following this installation. An undergraduate currently has funding through a university-sponsored grants program (IBS-CORE) to study this aspect throughout this summer and fall. As part of this study live-trapped deer mice have been marked with colored ear tags to designate on which side of the highway they were caught.

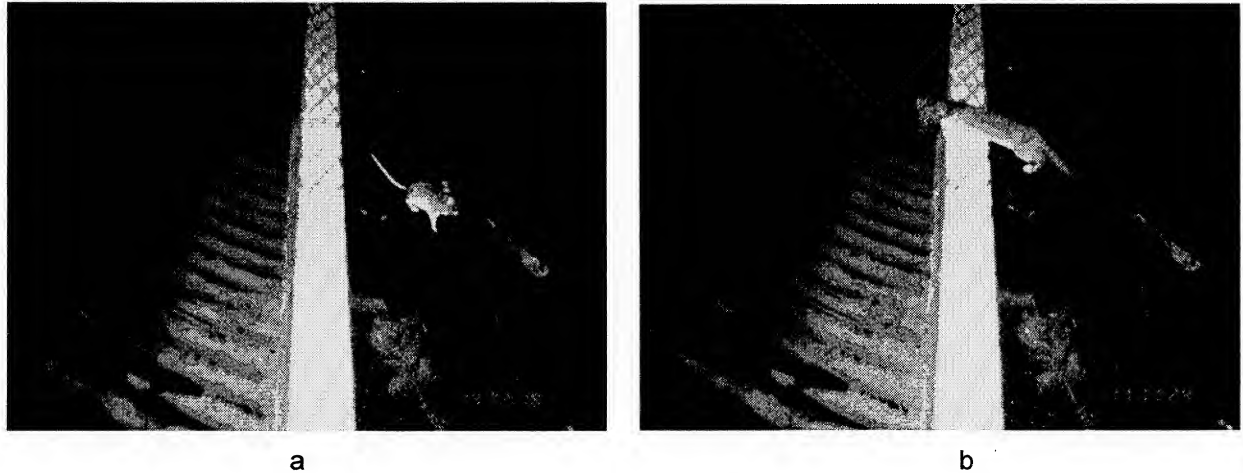
Figure 15. Animals using modified ramp surface. (a) Deer mouse, and (b) short-tailed weasel.

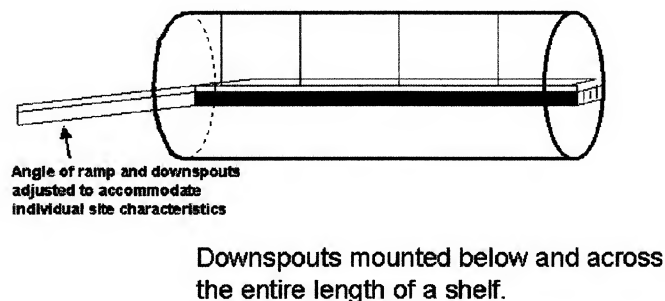
Figure 16. Suggested design of vole tubes to allow for movement under existing ramps.

Tests of a vole tube which could be placed below and supported by the existing shelves that would allow voles to move through the culverts in an enclosed space are being considered. These tubes would extend from the culvert entrances along the existing ramps so that they would open into the vegetation providing adequate cover for this species (Fig 16).
